**Flood Control Project Maintenance
Levee Inspections**

Maintenance Issue Types Only, Levee Inspection Report By Mile - Spring 2015

San Joaquin County Flood Control and Water Conservation District

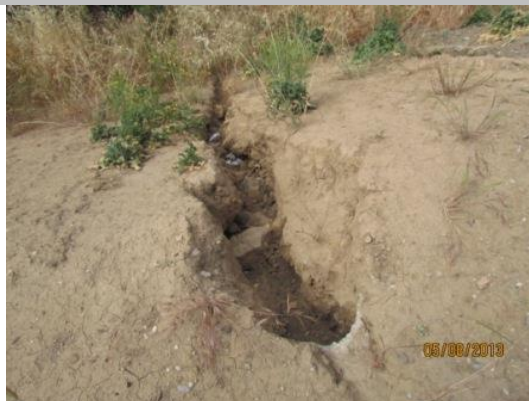
Photo 2 of 2 : SP_2015_NA0017_160_150_20150313_00088.jpg

Erosion was found on the landside of the levee looking downstream.

LM Start	16.43	Rating **	M	Issue No.	150 (cont)
LM End	16.43	Issue Type +	Ma	Location *	LS
Category	Earthen Levee			GPS Latitude/Longitude	
				Start	End
Item	Erosion / Bank Caving			37.982318 °	37.982318 °
				-121.252095 °	-121.252095 °
DWR ID	DWR_NA0017_16_s_2013_150				
Action/Comments					
Schedule repair of erosion site prior to the next inspection.					
Inspector Comments: Runoff

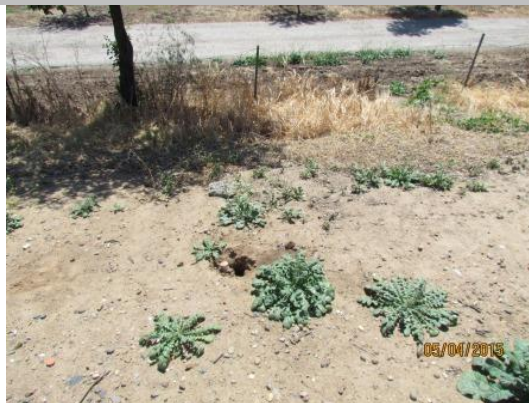
Photo 1 of 1 : SP_2015_NA0017_160_276_20150506_00171.jpg

Rodent holes were found on the landside toe of the levee looking downstream.

LM Start	19.88	Rating **	M	Issue No.	276
LM End	19.88	Issue Type +	Ma	Location *	LS
Category	Earthen Levee			GPS Latitude/Longitude	
				Start	End
Item	Animal Control			37.985971 °	37.985971 °
				-121.307357 °	-121.307357 °
DWR ID	DWR_NA0017_16_s_2015_276				
Action/Comments					
No rodents visible, but rodent burrows visible; need to backfill and compact or grout burrows.

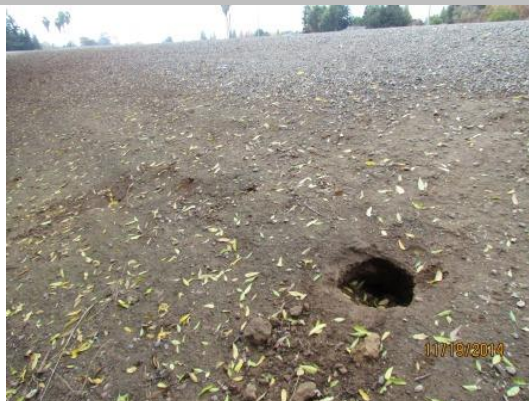
Photo 1 of 1 : SP_2015_NA0017_160_256_20150313_00148.jpg

An animal hole was found on the landside toe of the levee looking downstream.

LM Start	19.92	Rating **	M	Issue No.	256
LM End	19.92	Issue Type +	Ma	Location *	LS
Category	Earthen Levee			GPS Latitude/Longitude	
				Start	End
Item	Animal Control			37.985457 °	37.985457 °
				-121.307658 °	-121.307658 °
DWR ID	DWR_NA0017_16_f_2014_256				
Action/Comments					
No rodents visible, but rodent burrows visible; need to backfill and compact or grout burrows.

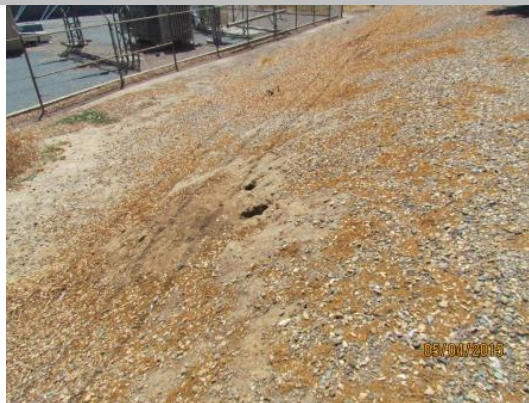
Photo 1 of 1 : SP_2015_NA0017_160_278_20150506_00173.jpg

Rodent holes were found on the landside of the levee looking upstream.

LM Start	20.58	Rating **	M	Issue No.	278
LM End	20.58	Issue Type +	Ma	Location *	LS
Category	Earthen Levee			GPS Latitude/Longitude	
				Start	End
Item	Animal Control			37.979405 °	37.979405 °
				-121.316733 °	-121.316733 °
DWR ID	DWR_NA0017_16_s_2015_278				
Action/Comments					
No rodents visible, but rodent burrows visible; need to backfill and compact or grout burrows.

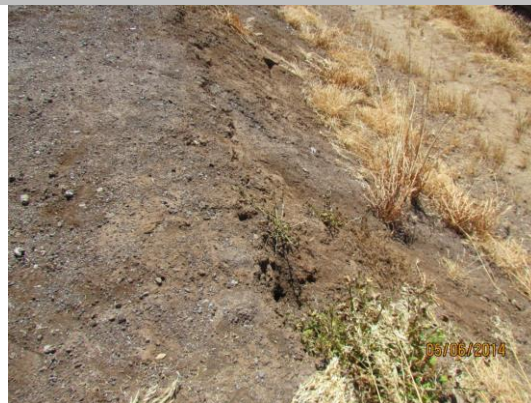
Photo 1 of 2 : SP_2015_NA0017_160_83_20150313_00045.jpg

View of rodent holes on the landside of the levee looking upstream during spring 2014 inspection.

LM Start	20.85	Rating **	M	Issue No.	83
LM End	20.85	Issue Type +	Ma	Location *	LS
Category	Earthen Levee			GPS Latitude/Longitude	
				Start	End
Item	Animal Control			37.980192 °	37.980192 °
				-121.320720 °	-121.320720 °
DWR ID	DWR_NA0017_16_f_2013_83				
Action/Comments					
No rodents visible, but rodent burrows visible; need to backfill and compact or grout burrows.

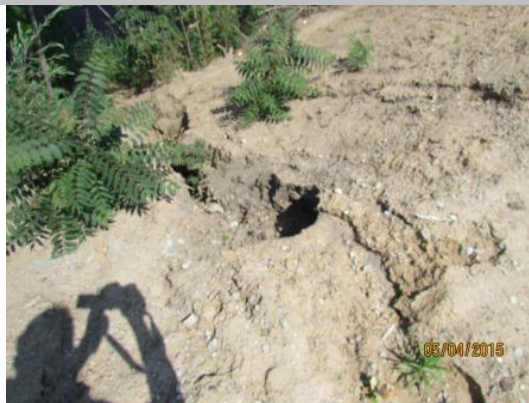
Photo 1 of 2 : SP_2015_NA0017_160_175_20150506_00174.jpg

Updated picture of the slope instability on the waterside shoulder looking upstream during spring 2015 inspection.

LM Start	20.90	Rating **	M	Issue No.	175
LM End	20.90	Issue Type +	Ma	Location *	WS
Category	Earthen Levee			GPS Latitude/Longitude	
				Start	End
Item	Erosion / Bank Caving			37.980477 °	37.980477 °
				-121.321656 °	-121.321656 °
DWR ID	DWR_NA0017_16_s_2013_175				
Action/Comments					
Schedule repair of erosion site prior to the next inspection.

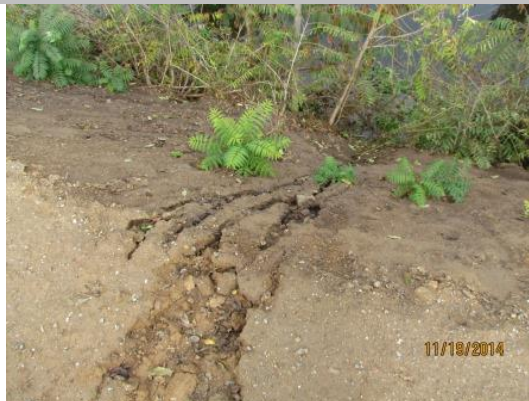
Photo 2 of 2 : SP_2015_NA0017_160_175_20150313_00110.jpg

Slope instability on the waterside slope of the levee looking downstream during fall 2014 inspection.

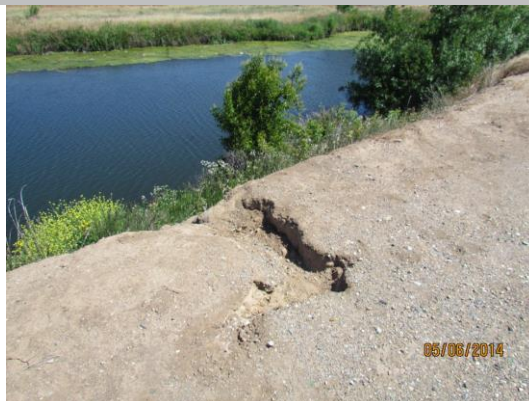
Photo 1 of 2 : SP_2015_NA0017_160_197_20150313_00122.jpg

Updated picture of the erosion on the waterside of the levee looking upstream during spring 2014 inspection.

LM Start	20.97	Rating **	M	Issue No.	197
LM End	20.97	Issue Type +	Ma	Location *	WS
Category	Earthen Levee			GPS Latitude/Longitude	
				Start	End
Item	Erosion / Bank Caving			37.980569 °	37.980569 °
				-121.322985 °	-121.322985 °
DWR ID	DWR_NA0017_16_s_2013_197				
Action/Comments					
Schedule repair of erosion site prior to the next inspection.

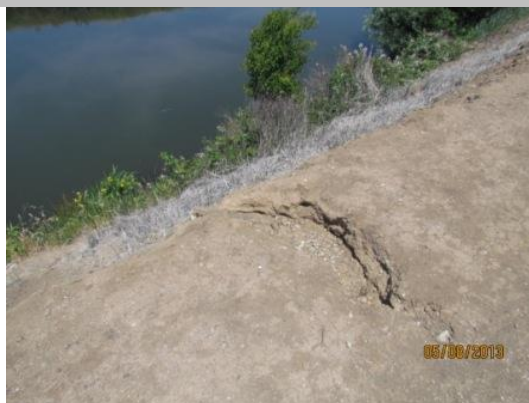
Photo 2 of 2 : SP_2015_NA0017_160_197_20150313_00123.jpg

LM Start	20.97	Rating **	M	Issue No.	197 (cont)
LM End	20.97	Issue Type +	Ma	Location *	WS

Erosion was found on the waterside slope of the levee looking upstream.

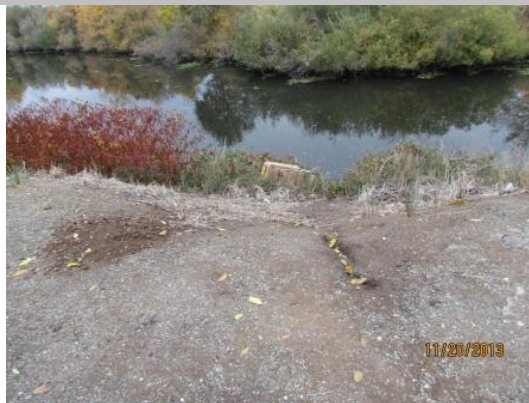
Photo 1 of 1 : SP_2015_NA0017_160_74_20150313_00042.jpg

LM Start	21.31	Rating **	M	Issue No.	74
LM End	21.31	Issue Type +	Ma	Location *	WS
Category	Earthen Levee			GPS Latitude/Longitude	
				Start	End
Item	Erosion / Bank Caving			37.980773 °	37.980773 °
				-121.328866 °	-121.328866 °
DWR ID	DWR_NA0017_16_f_2013_74				
Action/Comments					
Schedule repair of erosion site prior to the next inspection. Inspector Comments: Runoff

Erosion due to runoff was found on the waterside of the levee looking upstream.

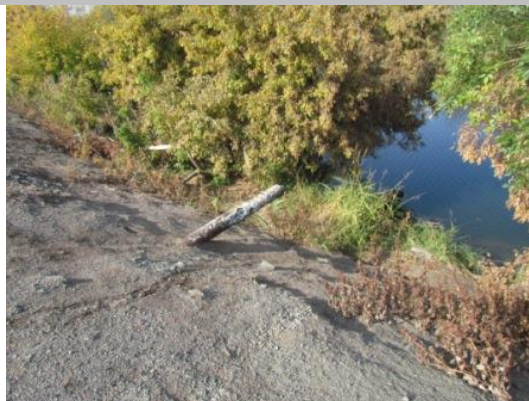
Photo 1 of 1 : SP_2015_NA0017_160_761_20150313_00160.jpg

LM Start	21.54	Rating **	M	Issue No.	761
LM End	21.54	Issue Type +	Ma	Location *	WS
Category	Earthen Levee			GPS Latitude/Longitude	
				Start	End
Item	Encroachments				°
					°
DWR ID	DWR_NA0017_16_s_2012_761				
Action/Comments					
Pipe

An abandoned pipe was found on the waterside of the levee looking downstream.

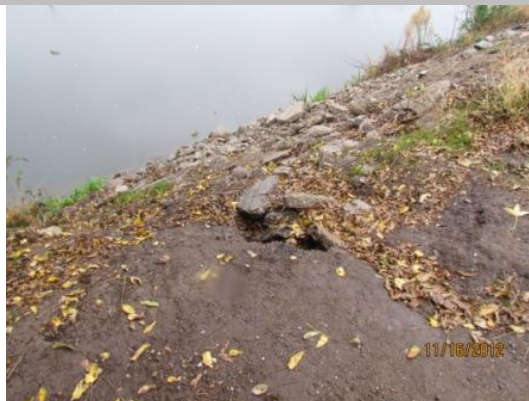
Photo 1 of 1 : SP_2015_NA0017_160_68_20150313_00038.jpg

LM Start	21.68	Rating **	M	Issue No.	68
LM End	21.68	Issue Type +	Ma	Location *	WS
Category	Earthen Levee			GPS Latitude/Longitude	
				Start	End
Item	Erosion / Bank Caving			37.979674 °	37.979674 °
				-121.335228 °	-121.335228 °
DWR ID	DWR_NA0017_16_f_2012_68				
Action/Comments					
Schedule repair of erosion site prior to the next inspection.

Erosion was found on the waterside slope of the levee looking upstream.

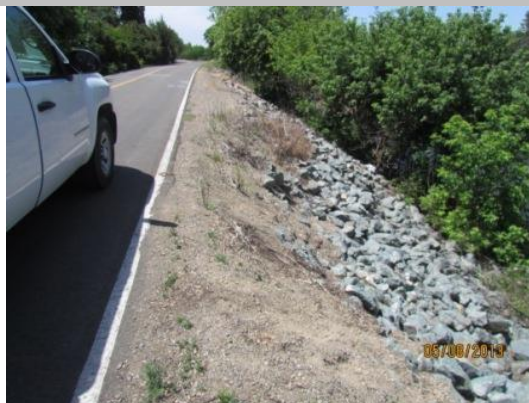
Photo 1 of 1 : SP_2015_NA0017_160_203_20150313_00125.jpg

LM Start	21.82	Rating **	M	Issue No.	203
LM End	21.82	Issue Type +	Ma	Location *	WS
Category	Earthen Levee			GPS Latitude/Longitude	
				Start	End
Item	Slope Stability			37.979412 °	37.979412 °
				-121.337810 °	-121.337810 °
DWR ID	DWR_NA0017_16_s_2013_203				
Action/Comments					
Repair slope instability.

Slope instability was found on the waterside slope of the levee looking downstream.

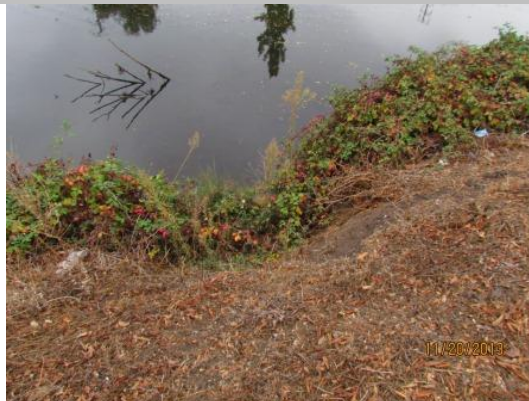
Photo 1 of 1 : SP_2015_NA0017_160_62_20150313_00034.jpg

LM Start	21.94	Rating **	M	Issue No.	62
LM End	21.94	Issue Type +	Ma	Location *	WS
Category	Earthen Levee			GPS Latitude/Longitude	
				Start	End
Item	Erosion / Bank Caving			37.979251 °	37.979251 °
				-121.340012 °	-121.340012 °
DWR ID	DWR_NA0017_16_f_2013_62				
Action/Comments					
Schedule repair of erosion site prior to the next inspection.

Erosion was found on the waterside slope of the levee looking upstream.

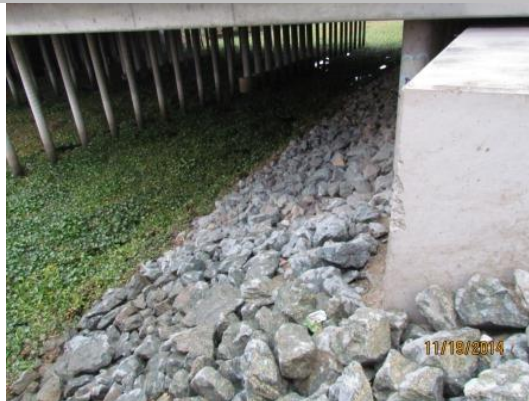
Photo 1 of 6 : SP_2015_NA0017_160_48_20150313_00019.jpg

LM Start	22.04	Rating **	A/W	Issue No.	48
LM End	22.04	Issue Type +	Ma	Location *	WS
Category	Earthen Levee			GPS Latitude/Longitude	
				Start	End
Item	Erosion / Bank Caving			37.978697 °	37.978697 °
				-121.341581 °	-121.341581 °
DWR ID	DWR_NA0017_16_s_2012_48				
Action/Comments					
Schedule repair of erosion site prior to the next inspection.					
Inspector Comments: Caltrans just repaired the issue. (Permit # 18532)

Caltrans repaired the erosion under the southbound (I-5) bridge. The picture was taken from the crown looking upstream during fall 2014 inspection.

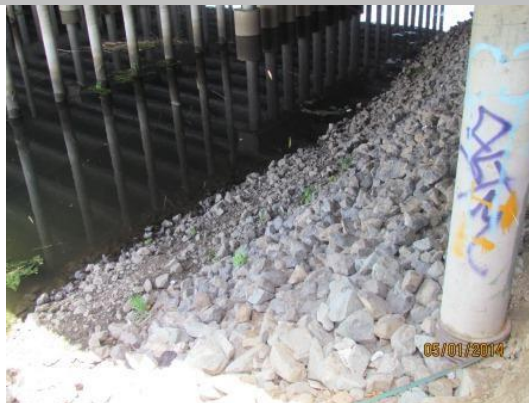
Photo 2 of 6 : SP_2015_NA0017_160_48_20150313_00020.jpg

Updated picture of the erosion under the (I-5) bridge by Caltrans. The picture was taken from the crown of the levee during spring 2014 inspection.

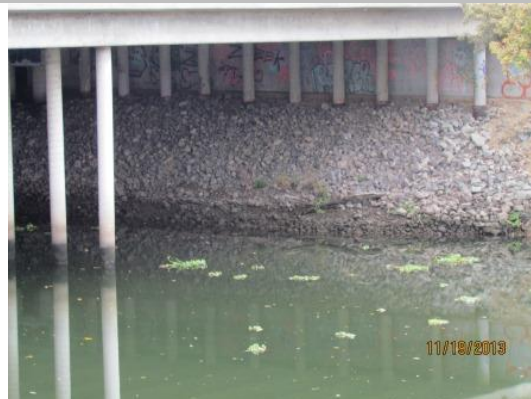
Photo 3 of 6 : SP_2015_NA0017_160_48_20150313_00021.jpg

LM Start	22.04	Rating **	A/W	Issue No.	48 (cont)
LM End	22.04	Issue Type +	Ma	Location *	WS
Category	Earthen Levee			GPS Latitude/Longitude	
				Start	End
Item	Erosion / Bank Caving			37.978697 °	37.978697 °
				-121.341581 °	-121.341581 °
DWR ID	DWR_NA0017_16_s_2012_48				
Action/Comments					
Schedule repair of erosion site prior to the next inspection.					
Inspector Comments: Caltrans just repaired the issue. (Permit # 18532)

Updated picture of erosion was found on the waterside toe of the levee looking from the opposite side of the levee.

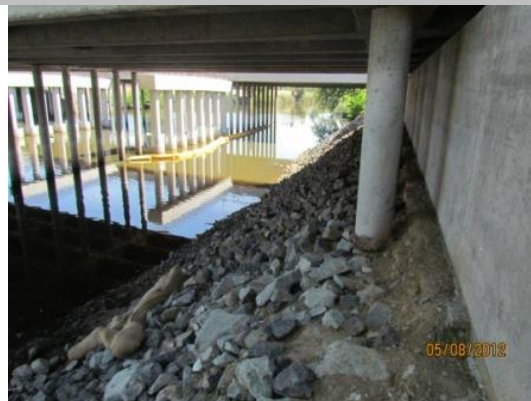
Photo 5 of 6 : SP_2015_NA0017_160_48_20150313_00023.jpg

View of the erosion site repaired by Caltrans under the I-5 freeway going southbound. This picture was taken from the toe of the levee looking upstream.

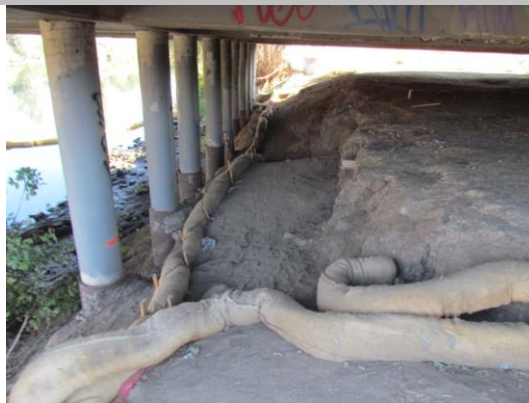
Photo 6 of 6 : SP_2015_NA0017_160_48_20150313_00024.jpg

LM Start	22.04	Rating **	A/W	Issue No.	48 (cont)
LM End	22.04	Issue Type +	Ma	Location *	WS
Category	Earthen Levee			GPS Latitude/Longitude	
				Start	End
Item	Erosion / Bank Caving			37.978697 °	37.978697 °
				-121.341581 °	-121.341581 °
DWR ID	DWR_NA0017_16_s_2012_48				
Action/Comments					
Schedule repair of erosion site prior to the next inspection.					
Inspector Comments: Caltrans just repaired the issue. (Permit # 18532)

View of the erosion under the I-5 bridge looking upstream.

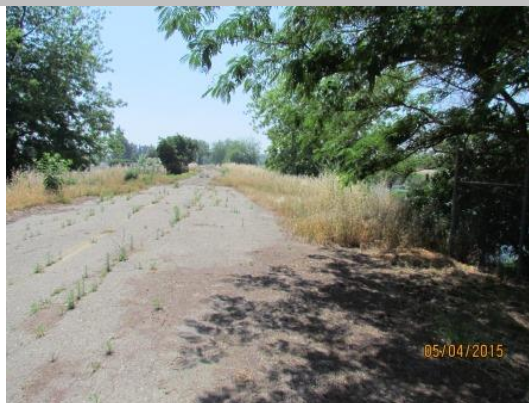
Photo 1 of 1 : SP_2015_NA0017_160_281_20150506_00175.jpg

LM Start	22.11	Rating **	M	Issue No.	281
LM End	22.58	Issue Type +	Ma	Location *	WS
Category	Earthen Levee			GPS Latitude/Longitude	
				Start	End
Item	Vegetation			37.978043 °	37.973164 °
				-121.342574 °	-121.348674 °
DWR ID	DWR_NA0017_16_s_2015_281				
Action/Comments					
Control annual grass and weeds on the levee slopes and easements.

View of vegetation along waterside of the levee looking downstream.

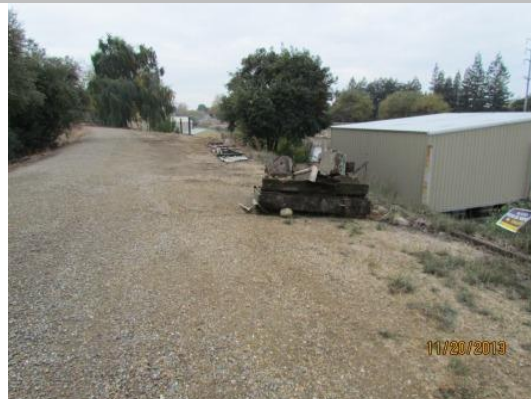
Photo 1 of 1 : SP_2015_NA0017_160_43_20150313_00017.jpg

LM Start	22.27	Rating **	M	Issue No.	43
LM End	22.27	Issue Type +	Ma	Location *	WS
Category	Earthen Levee			GPS Latitude/Longitude	
				Start	End
Item	Encroachments			37.976308 °	37.976308 °
				-121.344698 °	-121.344698 °
DWR ID	DWR_NA0017_16_f_2013_43				
Action/Comments					
Debris

Debris was found on the waterside shoulder of the levee looking downstream.

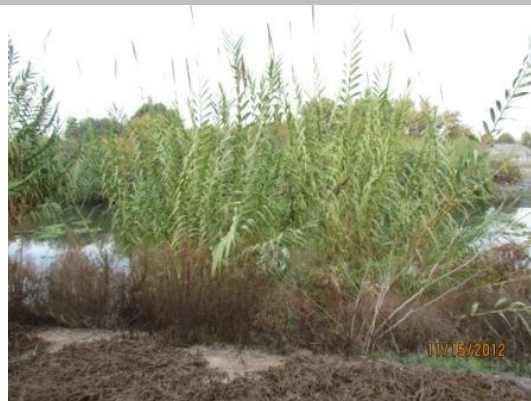
Photo 1 of 1 : SP_2015_NA0017_160_45_20150313_00018.jpg

LM Start	22.55	Rating **	U	Issue No.	45
LM End	22.55	Issue Type +	Ma	Location *	WS
Category	Earthen Levee			GPS Latitude/Longitude	
				Start	End
Item	Vegetation			37.973386 °	37.973386 °
				-121.348241 °	-121.348241 °
DWR ID	DWR_NA0017_16_f_2012_45				
Action/Comments					
Remove the wild growth other than native grasses from the levee slopes.					
Inspector Comments: Arrundo on the waterside of the levee.

Arundo was found on the waterside slope of the levee looking upstream.

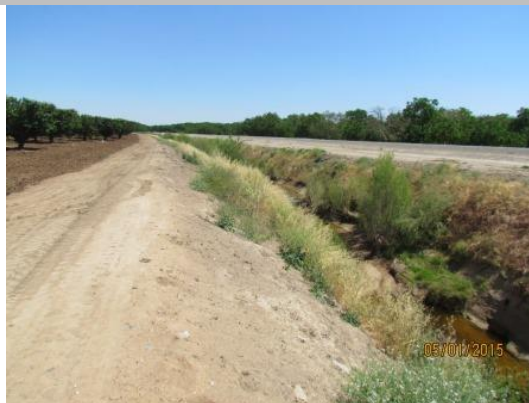
Photo 1 of 1 : SP_2015_NA0017_161_7_20150506_00008.jpg

LM Start	0.01	Rating **	M	Issue No.	7
LM End	0.32	Issue Type +	Ma	Location *	WS
Category	Earthen Levee			GPS Latitude/Longitude	
				Start	End
Item	Vegetation			37.960400 °	37.959196 °
				-121.163136 °	-121.157813 °
DWR ID	DWR_NA0017_17_s_2015_7				
Action/Comments					
Control annual grass and weeds on the levee slopes and easements.

View of vegetation along waterside looking upstream.

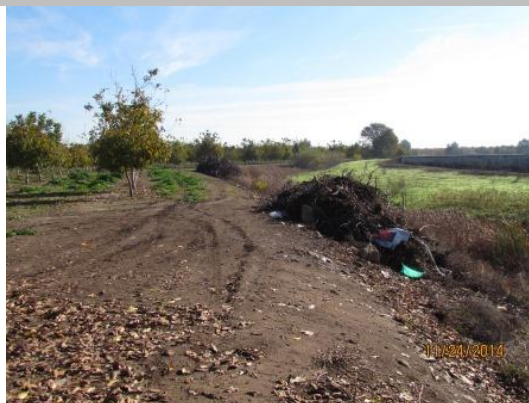
Photo 1 of 2 : SP_2015_NA0017_161_5_20150313_00004.jpg

LM Start	0.60	Rating **	M	Issue No.	5
LM End	0.60	Issue Type +	Ma	Location *	WS
Category	Earthen Levee			GPS Latitude/Longitude	
				Start	End
Item	Encroachments			37.958966 °	37.958966 °
				-121.152641 °	-121.152641 °
DWR ID	DWR_NA0017_17_s_2012_5				
Action/Comments					
Prunings

Updated picture of the prunings on the waterside of the levee looking upstream during fall 2014 inspection.

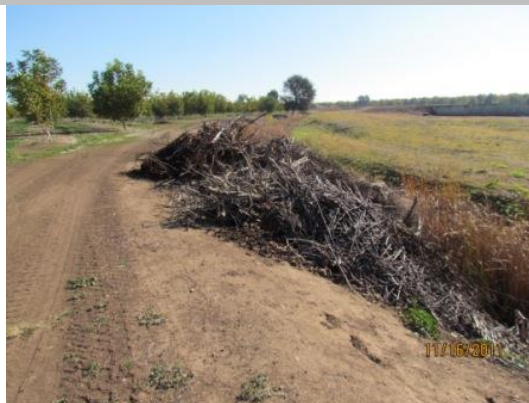
Photo 2 of 2 : SP_2015_NA0017_161_5_20150313_00005.jpg

Prunings were found on the waterside of the levee looking upstream.

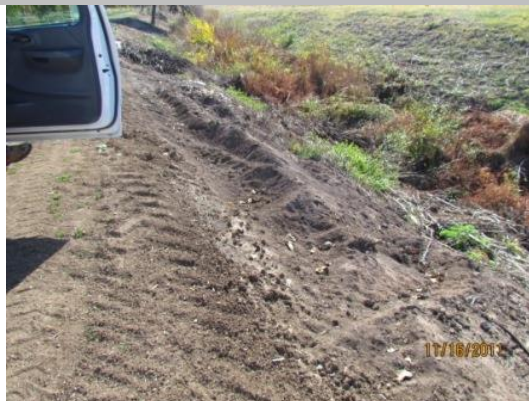
Photo 1 of 1 : SP_2015_NA0017_161_10_20150313_00007.jpg

LM Start	0.67	Rating **	M	Issue No.	10
LM End	0.67	Issue Type +	Ma	Location *	WS
Category	Earthen Levee			GPS Latitude/Longitude	
				Start	End
Item	Slope Stability			37.958702 °	37.958702 °
				-121.151544 °	-121.151544 °
DWR ID	DWR_NA0017_17_s_2012_10				
Action/Comments					
Repair the levee slope damaged by vehicle traffic and prevent access where possible.

Slope instability was found on the waterside of the levee looking upstream.

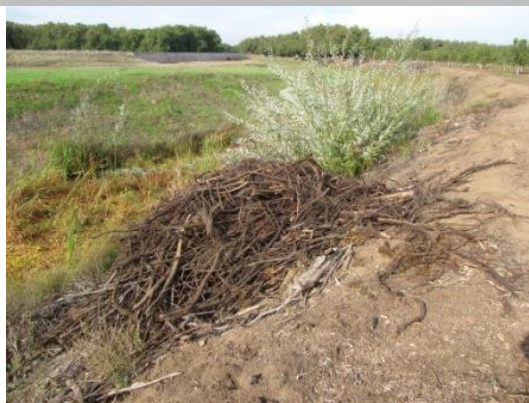
Photo 1 of 1 : SP_2015_NA0017_161_3_20150313_00002.jpg

LM Start	0.68	Rating **	M	Issue No.	3
LM End	0.68	Issue Type +	Ma	Location *	WS
Category	Earthen Levee			GPS Latitude/Longitude	
				Start	End
Item	Encroachments			37.958590 °	37.958590 °
				-121.151408 °	-121.151408 °
DWR ID	DWR_NA0017_17_s_2012_3				
Action/Comments					
Prunings

View of a prunings pile along the waterward bank looking downstream.

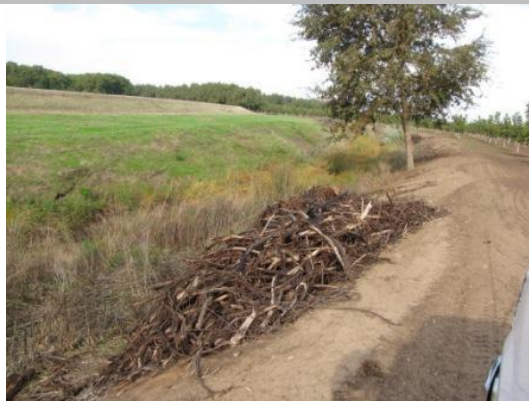
Photo 1 of 1 : SP_2015_NA0017_161_2_20150313_00001.jpg

LM Start	0.78	Rating **	M	Issue No.	2
LM End	0.78	Issue Type +	Ma	Location *	WS
Category	Earthen Levee			GPS Latitude/Longitude	
				Start	End
Item	Encroachments			37.957934 °	37.957934 °
				-121.149911 °	-121.149911 °
DWR ID	DWR_NA0017_17_s_2012_2				
Action/Comments					
Prunings

View of a prunings pile along the waterward bank looking downstream.

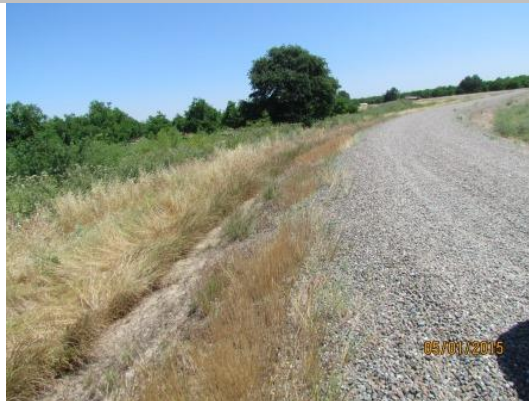
Photo 1 of 1 : SP_2015_NA0017_162_2_20150506_00002.jpg

LM Start	0.01	Rating **	M	Issue No.	2
LM End	0.21	Issue Type +	Ma	Location *	LS
Category	Earthen Levee			GPS Latitude/Longitude	
				Start	End
Item	Vegetation			37.957556 °	37.958479 °
				-121.148701 °	-121.151839 °
DWR ID	DWR_NA0017_18_s_2015_2				
Action/Comments					
Control annual grass and weeds on the levee slopes and easements.

View of vegetation along waterside looking upstream.
